**Radiology Visit to Kisiizi
Hospital
October 2009**

Report

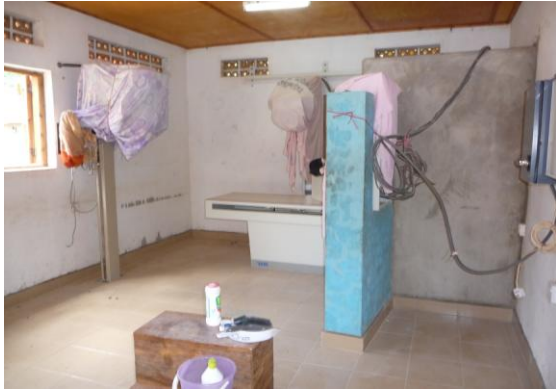
The department itself was in a state of disarray and the x-ray and ultrasound rooms were out of action. This was because an extension to accommodate the new ultrasound machine had just been completed and the builders were in the process of tiling the floors. Before the new extension was built the radiology department consisted of one x-ray room and one dark room. An old ultrasound machine was located in a small room adjacent to the maternity ward.

X-ray Room on arrival

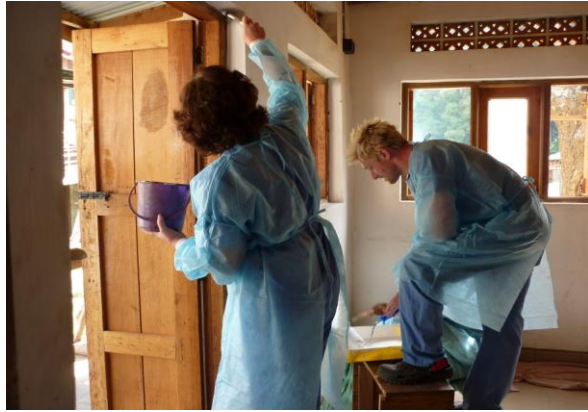
Decorating

We recommended that certain things be achieved before our next visit. These were finishing off the building works such as plastering and painting to keep the dust down, no entry signs, bolts on doors, curtains and rails put up, seats in waiting room, step in x-ray room and removal of old equipment. These jobs are very achievable within the time frame. We also asked that they keep up with regular maintenance of the processor and darkroom to ensure good quality images continue. We discussed the importance of continuing to follow the radiation protection guidelines that we had implemented. We also showed them where to find information for themselves in the various reference books we had taken and gave them each a personal log book to complete before our next visit. A list of all our contacts numbers was put into a department file so that we can be easily contacted between visits

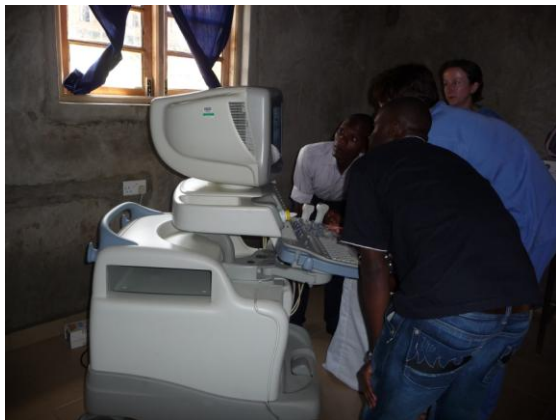
The new machine was unpacked and we checked its condition. The console had been cracked during transportation and two probes (3.5 MHz curvilinear and 7MHz linear) were missing. This is very unfortunate as they are the ones most generally used. However, the local population is smaller than that of the UK and we were able to use the 7C probe. These problems were relayed to the EBME department in Chester and contact was made with GE who assured us that the probes had been sent with the machine from their depot. This will have to be looked into on our return

Setting the Ultrasound machine up

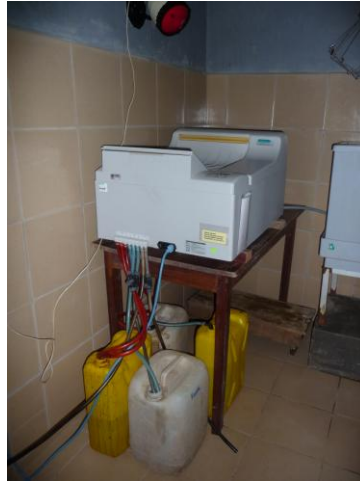
We took a desk top automatic processor with us which was very kindly donated by Carestream Health UK Ltd and as soon as the darkroom was ready we installed it. Unfortunately we had lots of problems getting it up and running. The main problem was that the chemicals Kisiizi had weren't suitable and despite many attempts to alter running temperatures etc we had to send to Kampala for automatic processing chemicals. With an 18 hour round trip this caused us huge delays but it did have a positive side. Whilst we were problem solving and taking the machine apart to sort the various problems, the three radiographers were able to watch and help us. This gave them valuable experience at trouble shooting, something that they will almost certainly need to do at some point in the future. The water supply in the darkroom is good but has low pressure which is ok for washing but won't replenish the automatic processor. This will have to be looked into on our return to the UK. Eventually when the processor was running efficiently we were able to produce some very good quality radiographs. It will make a big difference to the film quality, ease the workload and reduce the risk of errors been made in identifying films. The radiographers were thrilled with this piece of equipment. We also gave tuition in regular maintenance of the processor including mixing and sourcing new chemicals.

The new automatic processor

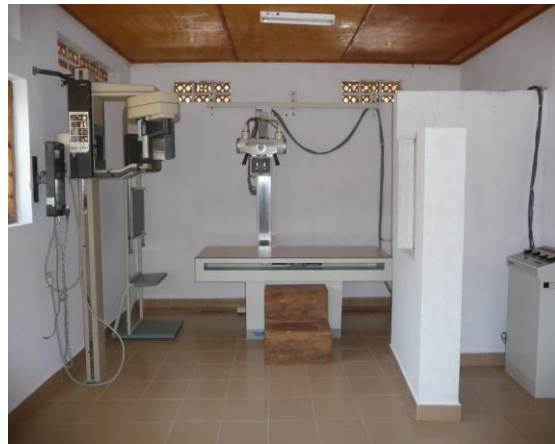
Finished x-ray room
