**Countess of Chester
Radiology Department
Visit to Kisiizi Hospital**

May 2012

Report

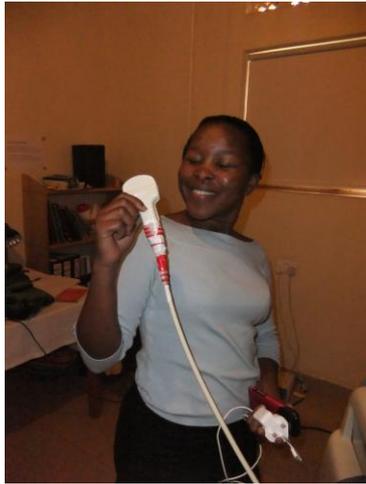
Brenda repairing the probe

The Main ultrasound machine the GE Logic 9 was in reasonable condition. The trackball required cleaning and the hard drive needed to be cleared as it was causing the unit to run slowly. The sonographers were instructed how to do this and also it was suggested that this general maintenance was done on a regular basis. Two of the knobs were broken and these have been temporarily fixed using ballpoint pen tops – these work adequately and can be cheaply replaced as required. The 3.5 MHz transducer cable has been damaged for some time and has been re-repaired using available materials. Ideally it should be replaced. The filter is rather ragged and a template was taken to see if one could be made to fit from appropriate material. Failing this then a replacement from GE should be sought.

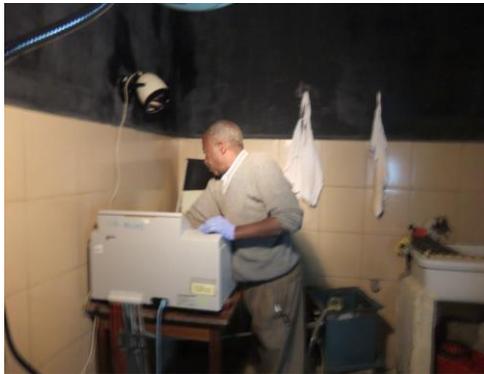
Ezra maintaining the processor

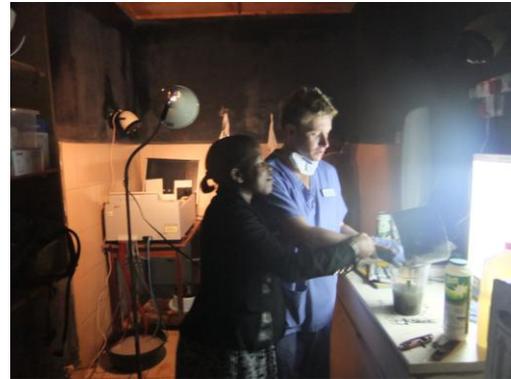
Collecting recovered silver

The silver recovery unit was emptied and is successfully working. It is showing a small amount of silver halide which was dried and kept in Radiology. Unfortunately the sump was emptied two months earlier. Relevant staff have been trained on the appropriate procedure to clean the unit and safely and efficiently retrieve the silver halide. It is therefore hoped future silver halide retrieval will be more substantial.

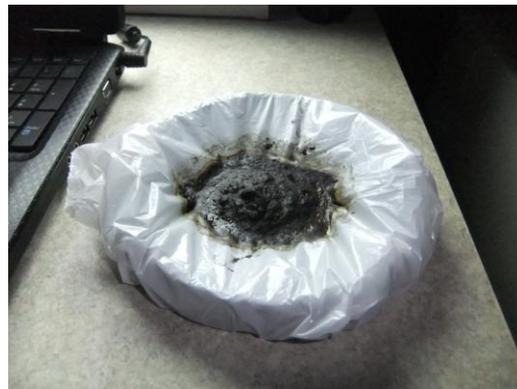
Silver collected over 12 months

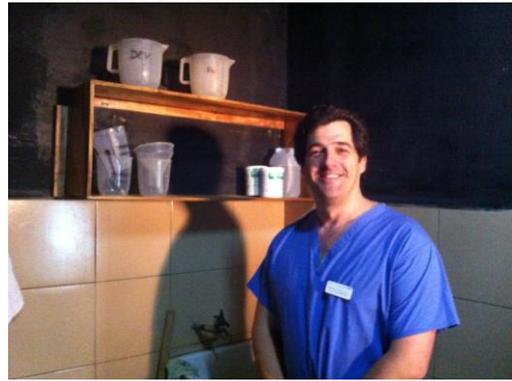
Darren with the new shelves

Historically equipment used for cleaning/replacing chemicals has been stored within the darkroom on a rusty table. This was an undoubted hazard to all personnel working in this area combined with the rust particles creating a major cause of dirt to the

processor creating damage and contamination to both pre processed and processed films damaging diagnostic quality of all resultant films. This was removed and the carpenter commissioned to fabricate and install a new wall mounted wooden shelving unit. The outcome was a cleaner, safer environment with the benefit of improved access to equipment and greater floor space.

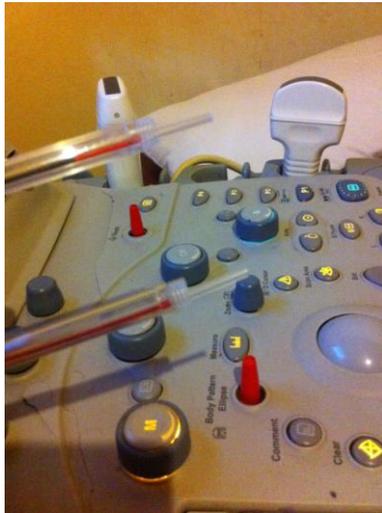
Simple repairs done to the logic 9

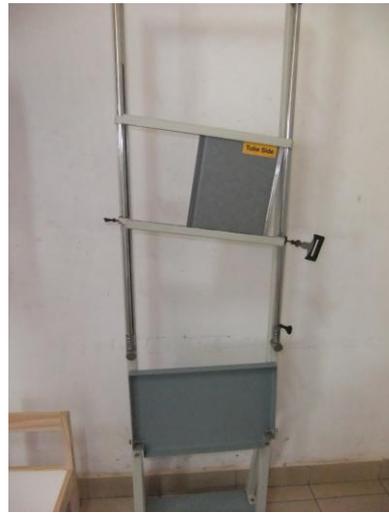
Chest stand to be repaired at next visit

The chest stand remains in a poor state of repair, and to date an acceptable replacement has yet to be found. A successful repair has been made allowing the unit to continue in safe and adequate use for some time to come. However a more substantial repair can be achieved by the design and fabrication of certain parts that may be simply replaced allowing the unit an increased lifespan. Dimensions to assist the design process shall be obtained with the hope that the new part may be fabricated and installed by the next visit in October 2012. If successful this shall negate the need to replace the whole unit, indeed the latest quote received for such a replacement was obtained by Moses during June 2012 and was for \$1800. This quote made no reference to delivery costs, installation costs or taxes.

A new 24x30cm grid lid was provided and its operation demonstrated. This requires less radiation to generate an image. However the chest stand would benefit from some modification to accommodate this. This is likely to be addressed during the chest stand part fabrication.

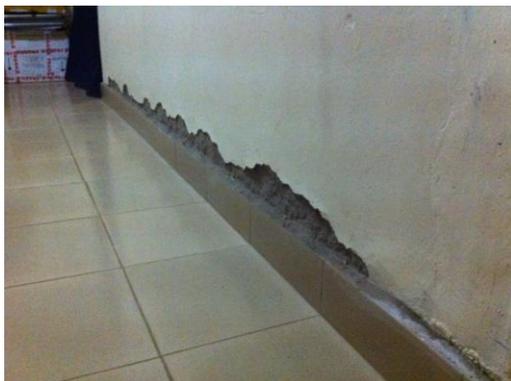
Damp in rooms needs attention
